# State of California Department of Public Works Division of Highways Materials and Research Department November 1961

SAN JOSE STATE COLLEGE

SOUND SURVEY OF VENTILATION SYSTEM NOISE

IN SPEECH-DRAMA BUILDING ADDITION

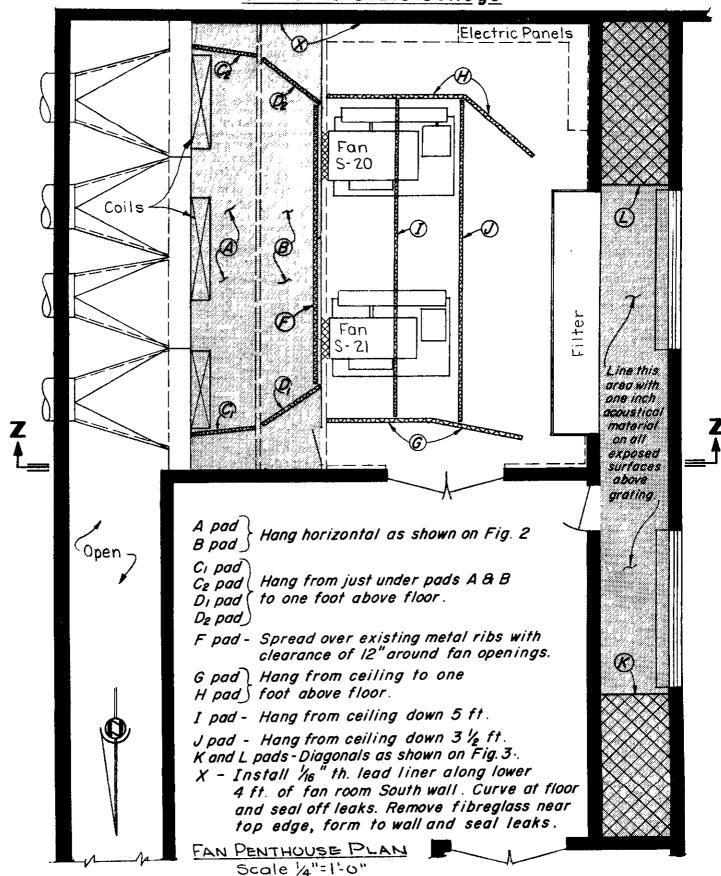
The intense noise levels developed within the fan room are due to very high fan (and air) velocities and inadequate acoustical damping of the open air spaces. This leads to strong excitation of all possible room modes from frequencies as low as 28 cps for the 20 foot fundamental and 51 cps for the 11 foot fundamental. Harmonics of these frequencies extend throughout the audible range and are mixed with intense white (hissing) noise generated by the air action across sharp edges and turns. If at all possible, the fan speeds should be reduced at least 25 percent. There is evidence of excessive delivery in many rooms because of the abundance of white noise that is now generated across the diffuser blades at the room outlets. 4,5,6,7

The lead (metal) liner X along the lower south side of the fan room (Figure 1) reduces noise penetration into the return air space above the rooms.

Recommended acoustical treatment and modifications are shown on Figures 1, 2, and 3. All acoustical pads are of the type shown on Figure 4. The materials recommended and method of fabrication are described.

Pads C1 and D1 (in Figures 1 and 2) should be wide enough so that they may be tied together where they meet at the dividing grille so as to minimize the air gap at this junction. The same comment applies to pads C2 and D2.

The diagonal pads K and L, in the return air shaft (Figures 1 and 3), should be mounted with their edges snugly against the walls to minimize air gaps at all pad edge and wall junctions.

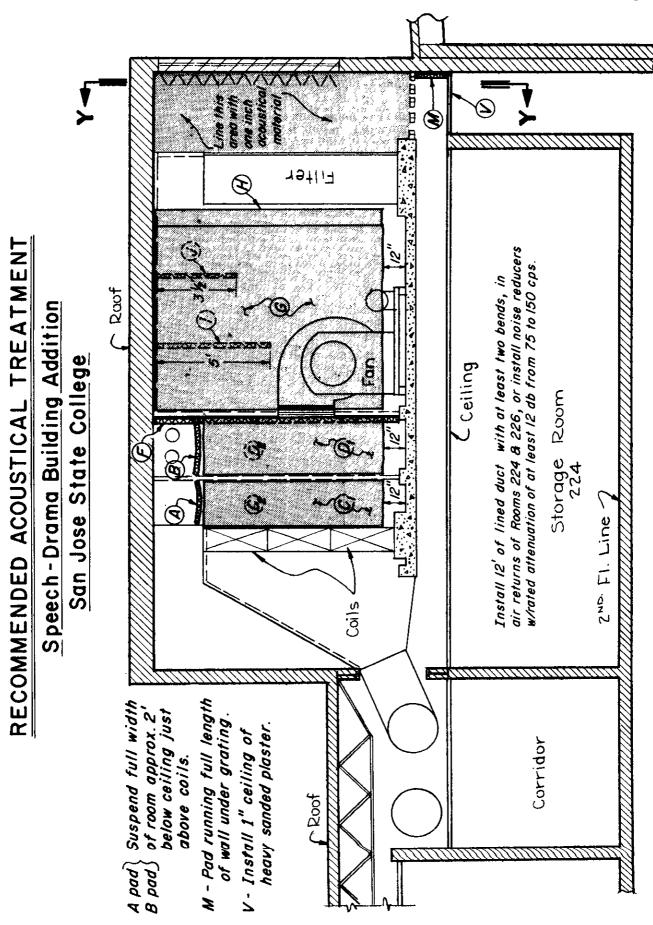
The noise levels are highest in the rooms immediately under the fan room, namely Rooms 224 and 226 which are specific areas of complaint.

Ceiling V (Figure 2) should be built as a standard ceiling to seal off the unused portion of the return air shaft and reduce noise penetration to Rooms 224 and 226.

Instructions on Figure 2 recommend means for reducing noise penetration via the return air openings in Rooms 224 and 226.
